Manhole Inspection Summary

Manhole # S57EE_011MH

Insp Date: **6/5/08 10:40 AM**

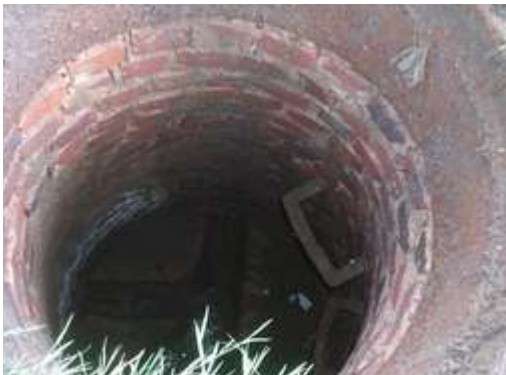
Defect 2

Frame minor surface corrosion

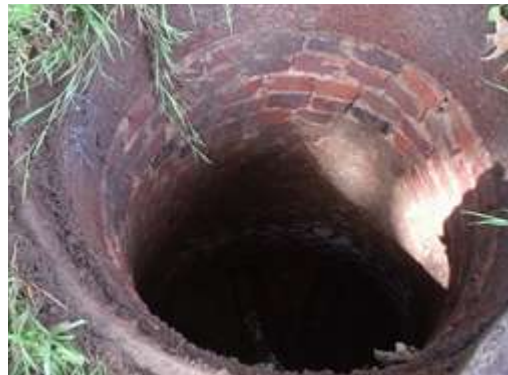
Defect 1

Loose brick joints.

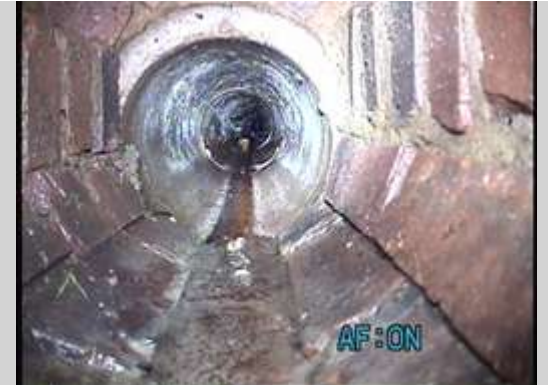
12 O'Clock Outflow

8 in. Circular Gravity Sewer
Pipe Out @ 12 O'Clock

Pipe Height: **8.4** (in.) Rod and Bar (Angled)
Pipe Material: **Clay** ☐ Pipe Lined
Invert Depth: **8.55** (ft.) Flow Characteristics: **Fast**
Deposits: ☒ None ☐ Mud ☐ Sludge ☐ Debris ☐ Grease
Silt Depth: (in.) Deposits Extent:
Infiltration: **None** Pipe Seal Cond: **Sound**

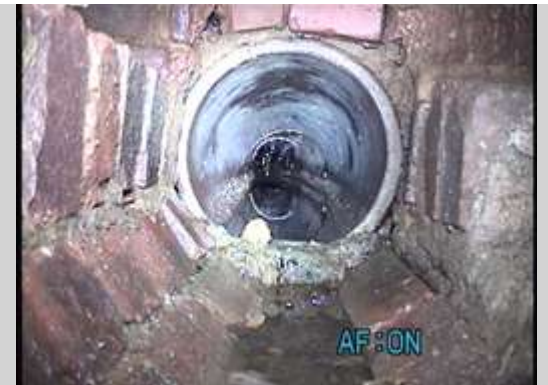
6 O'Clock Inflow

8 in. Circular Gravity Sewer
Pipe In @ 6 O'Clock

Pipe Height: **8.4** (in.) Rod and Bar (Angled)
Pipe Material: **Clay** ☐ Pipe Lined
Invert Depth: **8.40** (ft.) Flow Characteristics: **Fast**
Deposits: ☒ None ☐ Mud ☐ Sludge ☐ Debris ☐ Grease
Silt Depth: (in.) Deposits Extent:
Infiltration: **None** Pipe Seal Cond: **Sound**

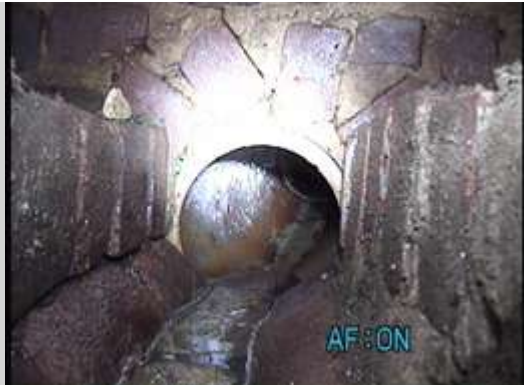
7 O'Clock Inflow

6 in. Circular Gravity Sewer

Pipe In @ 7 O'Clock

Infiltration: **None**

Pipe Seal Cond: **Sound**

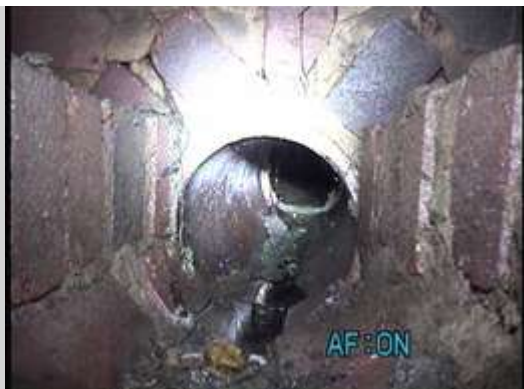
9 O'Clock Inflow

6 in. Circular Gravity Sewer

Pipe In @ 9 O'Clock

Infiltration: **None**

Pipe Seal Cond: **Sound**
